# Experiences of using monitoring system in buildings

**EFFECT4buildings Toolbox:**  
Technological solutions; Annex 3

The project “Effective Financing Tools for implementing Energy Efficiency in Buildings” (EFFECT4buildings) develops in collaboration with public building managers a comprehensive decision-making support toolbox with a set of financial instruments: Financial calculation tools; Bundling; Funding; Convincing decision makers; Energy Performance Contract; Multi Service Contract; Green Leasing Contract; Prosumerism. The tools and instruments chosen by the project has the biggest potential to help building managers to overcome financial barriers, based on nearly 40 interviews with the target group. The project improves these tools through different real cases.

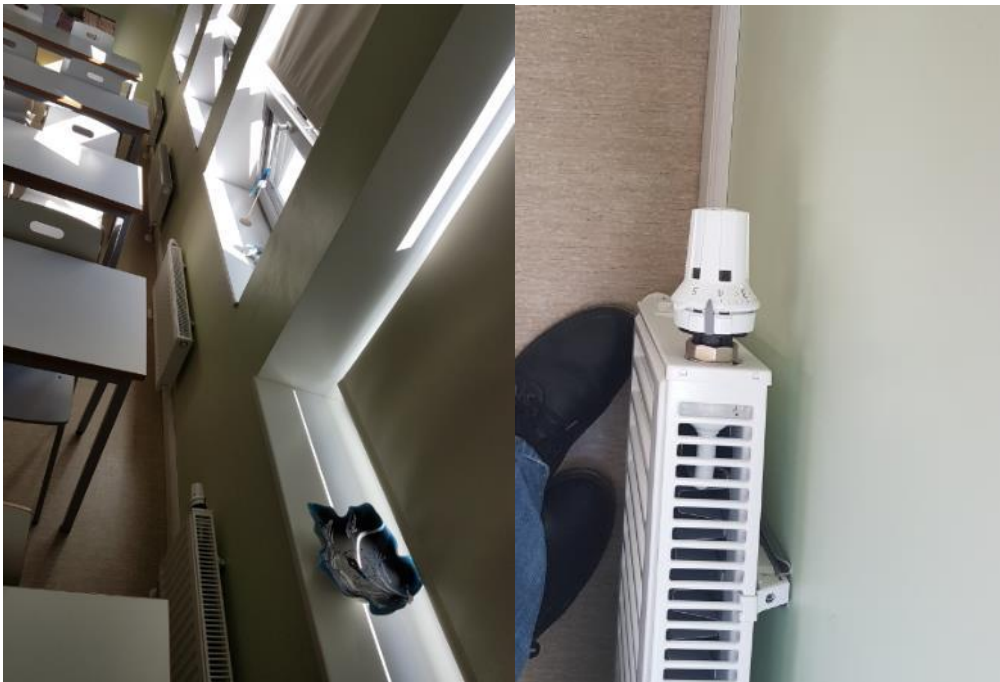
- The building automation has a lot of unpinned alarms.
- The person performing on-site maintenance is unable to receive operational information about alarms.
- The spacious client automation is built only in floor-heated rooms (mainly basement). In classrooms and other rooms there are manually configurable thermostats for radiators. In one room, different radiators could have set the settings to a minimum.
- The heating pump nodes are not connected to the machine automation.
- If the premises are overheated, the windows will be opened, but the thermostats of the radiators will not be set on minimum, and the radiators will therefore be asked to continue.

Figure 3. The windows are open due to overheating and the radiators are switched on

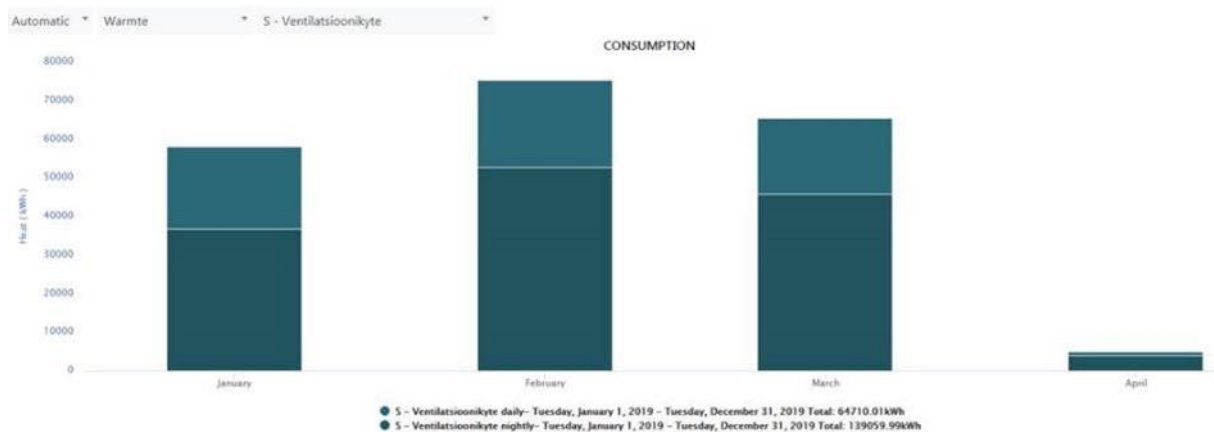
- The temperature settings of the ventilation systems in the inlet air are constant - accompanied by excessive heat consumption and limiting the capacity of the ventilation systems to the free cooling.
- The airflow settings do not correspond to design airflows. The air flow rates are too small and it resulted poor air quality.
- The configurations of the building automation and the ventilation equipment are not in line-ventilation equipment works according to the slow program of both controllers, which causes anomalies.
- In the ventilation controls, the default setting is "low speed", which makes the equipment work all the time, although it should stop in the meantime.

Figure 9. High energy consumption associated of ventilation systems

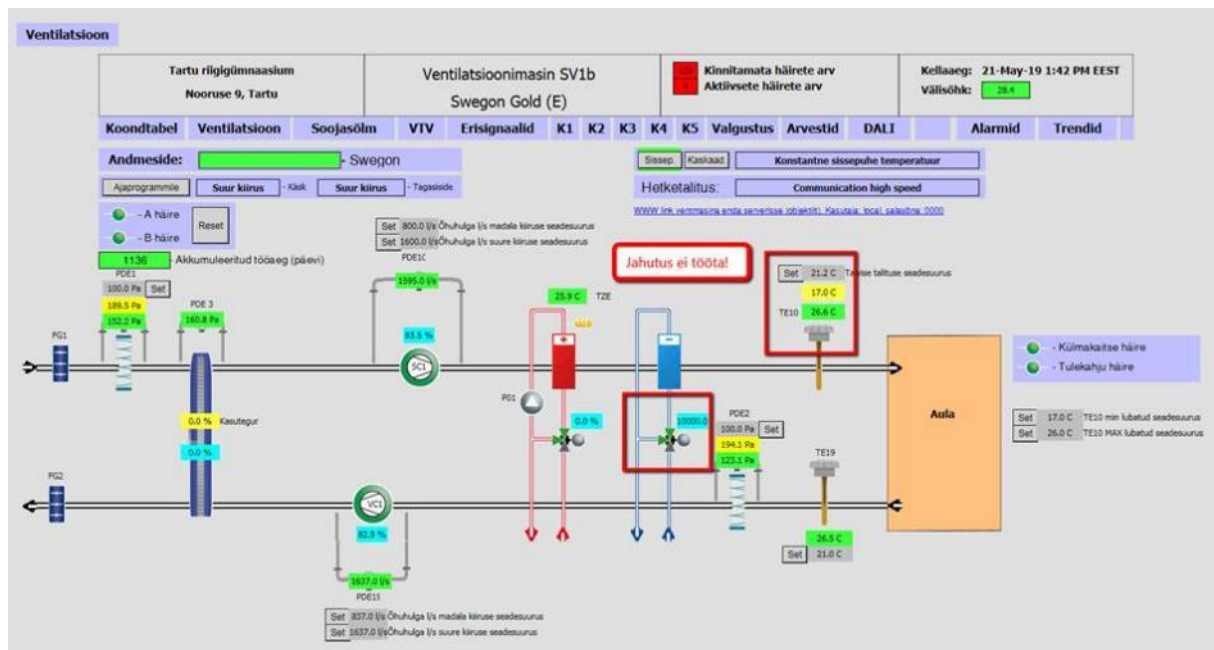
- There is no information about how the operation of exhaust ventilation V6 and V7 is controlled – constant pressure, constant speed or something else?
- The user does not have the possibility to turn on the ventilation systems quickly and operationally outside the working hours.
- There is no demand-controlled air change – the assembly hall, gym and auditorium ventilation units operate at a constant flow rate according to the time program.

Figure 10. Ventilation device cooling is not operational

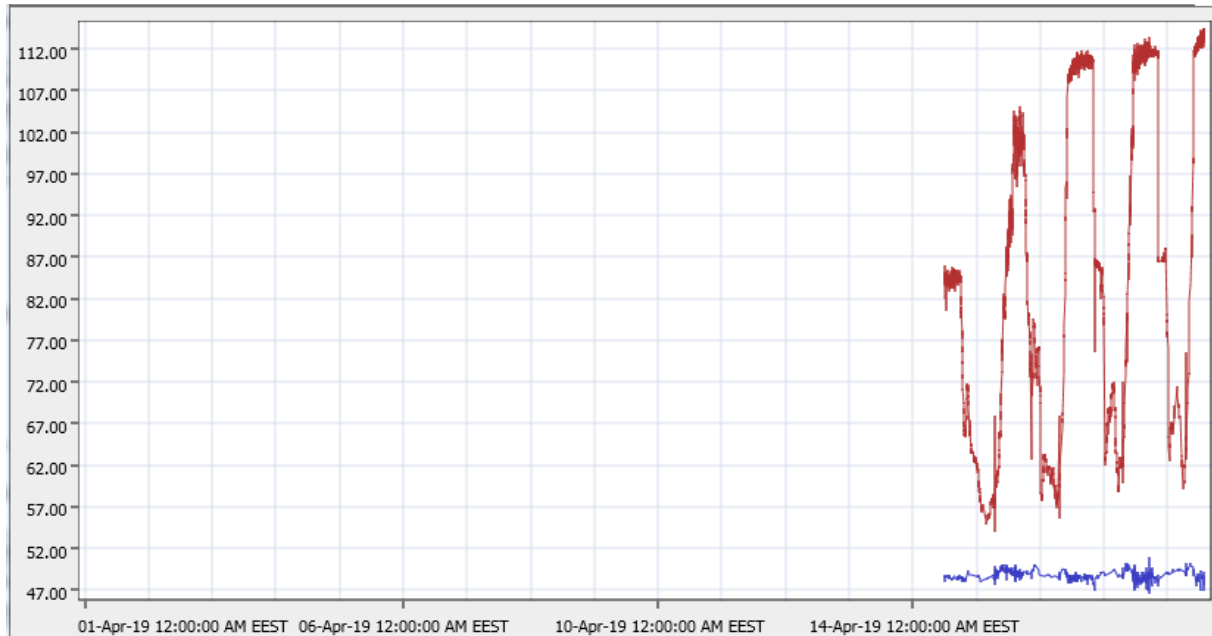
- The trends are missing air flow rates for ventilation equipment, which are critical parameters.
- Trend data in BMS is intermittent and too short.

Figure 11. Trend history is too short

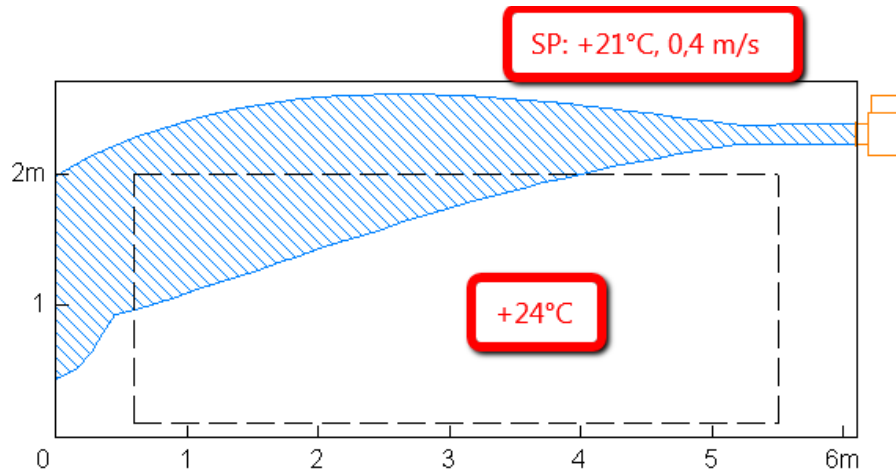
Figure 21. The Inlet to the entrance zone falls into the pupils-zone and the result is discomfort.

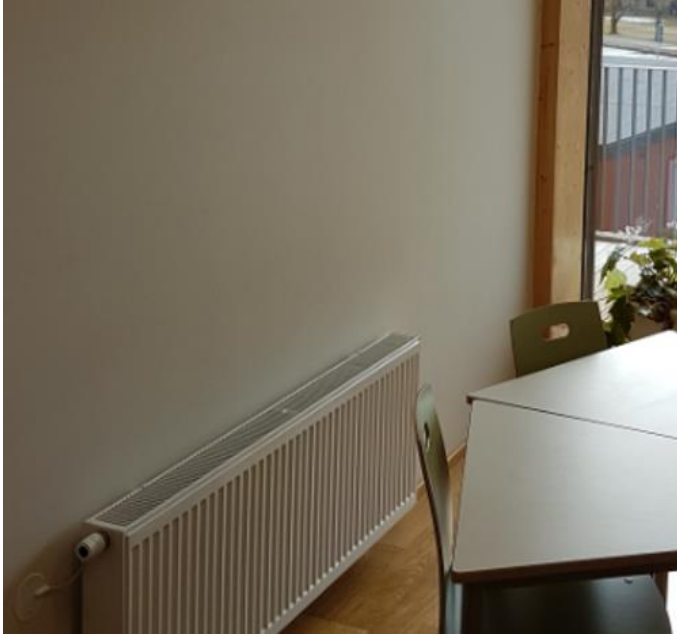
- Incorrect radiator position. In classrooms there are almost a wide range of windows that should be faced with radiators that generate the windows in the heating period in warm air as a "curtain", which reduces the window's low radiated temperature effect and heats up a cool air flow in front of the window. In practice, the radiators are mounted on the inner wall, which provide the necessary heating power in the room, but does not reduce the discomfort caused by the cold window.

Figure 22. Inappropriate placement of the radiator

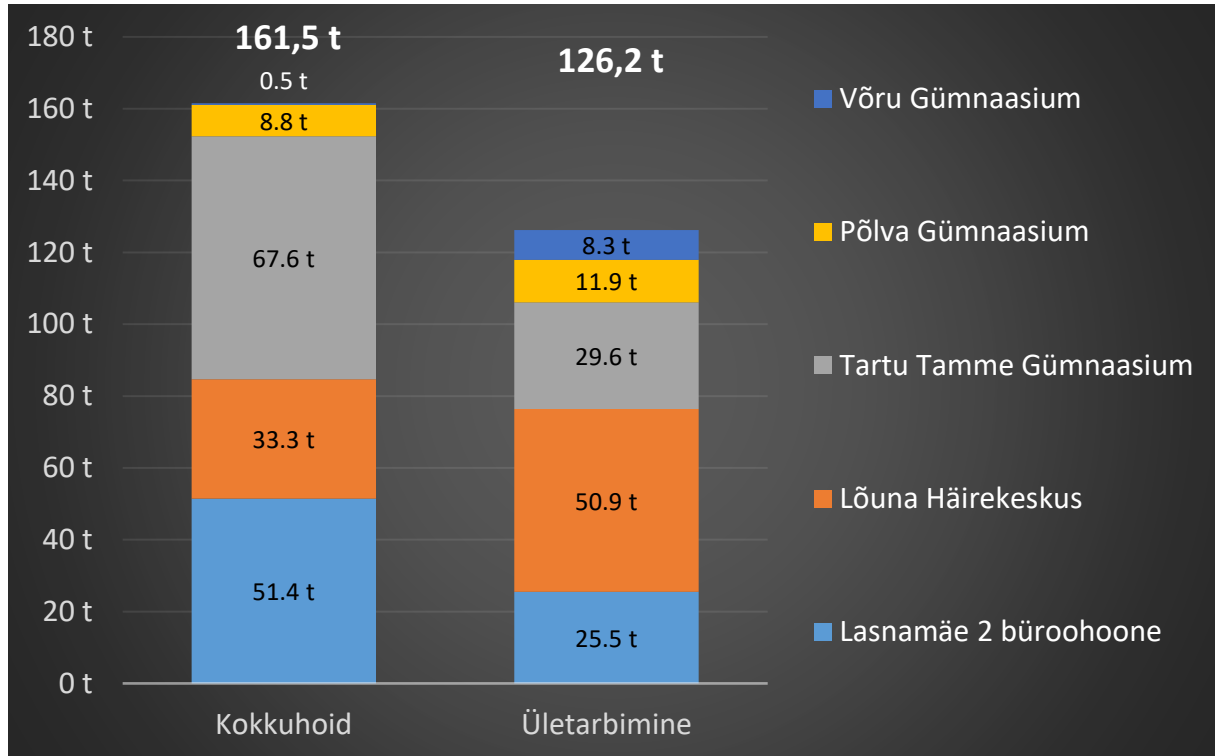
Figure 33. Reduction of greenhouse gas emissions from energy savings during the project period and estimated amount of total consumption emissions, CO2 equivalent

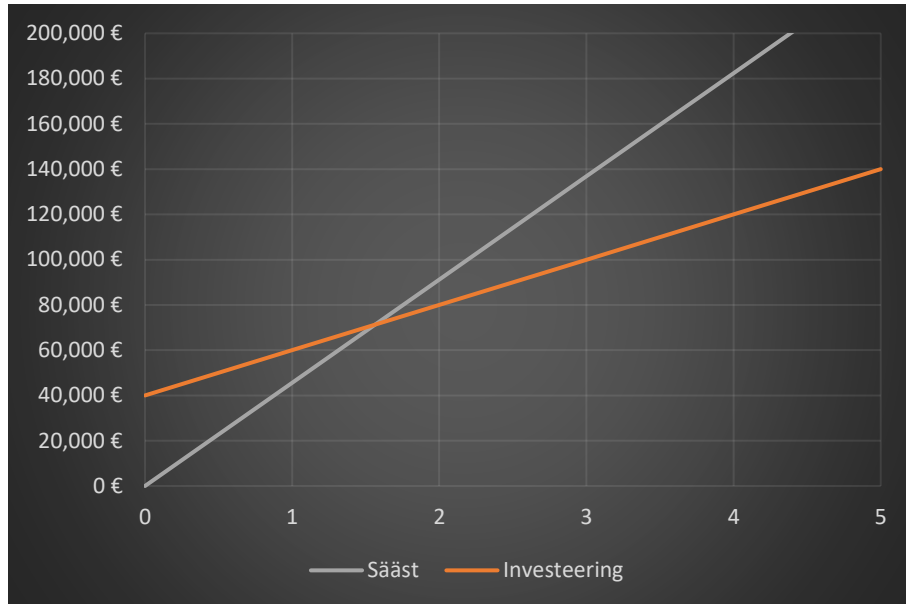
Figure 52. Potential savings in the light of the solution payoff time
